Sanitary Sewer Overflow (SSO)/Bypass Notification Form

4.	SSO Discharge to:	Ground Surface with extremely small amount to downgradient catch basin Ground Surface, Direct to Receiving Water, Catch Basin to Receiving Water, Backup into Basement
	Specify:	Most if any leakage to surface localized to ground/grass area.
Lo	ocation: <u>29 Roose</u>	velt Ave., Hull, MA
		(Description of discharge site or closest address)
)	K.Y Coordinates Lat: 42.27	'2958; Long: -70.863652

Unauthorized Discharge Summary 29 Roosevelt Ave. Hull, MA [05-16-20]

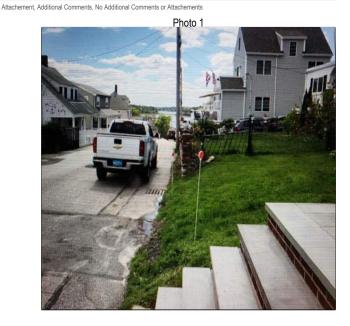
Downgradient CB with silt sack installed

7.	Corrective Actions :	A silt sack/filter fabric installed under the CB grate, until digsafes completed and contractor work completed. A trickle of flow was seen to be coming out of the ground from 2:15pm to 4:30pm, and then it stopped. The estimated quantity of leak was based upon this observation No additional leakage was seen until the contract work started at approximately 8pm. Contractor repairs completed by 11:59pm 05/16/20. The source of the pipe
	Impact Area cleaned and/o	r disinfected: Yes Corrective Actions Completed: Yes
	Details:	All areas cleaned up by contractor. A call was made for a vactor truck on Sunday 5/17 and scheduled in at 7AM on Monday 5/18 to pump out and washdown/clean the down gradient catch basin. There was no rain during the period from Saturday evening to Monday morning, and the catch basin had no standing water in it.

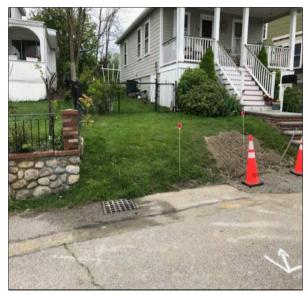
Catch basin [CB] in background - trickle of flow from area of break

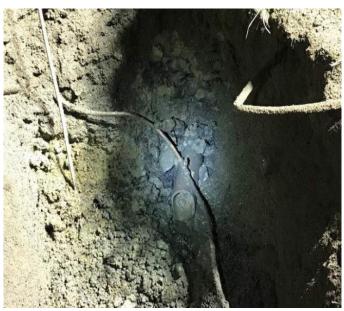
Broken pipe service

Corrective actions taken to prevent reoccurrence of unauthorized discharges at the same location;	Sub-Contractor repaired the broken pipe.
Date of the last unauthorized discharge in the same general location;	Unknown, NA.

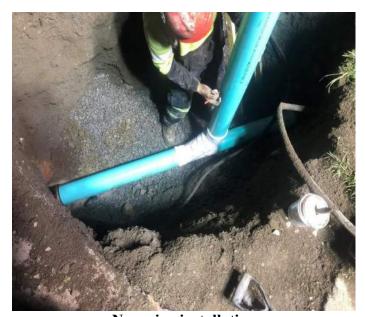
New pipe installation
